## **ARBORICULTURAL IMPACT ASSESSMENT**

SOUTHLANDS SOLAR FARM AND BATTERY STORAGE  
LAND SOUTH OF RUNWELL ROAD (A132), RUNWELL, WICKFORD  
P19-AIA OCTOBER 2022

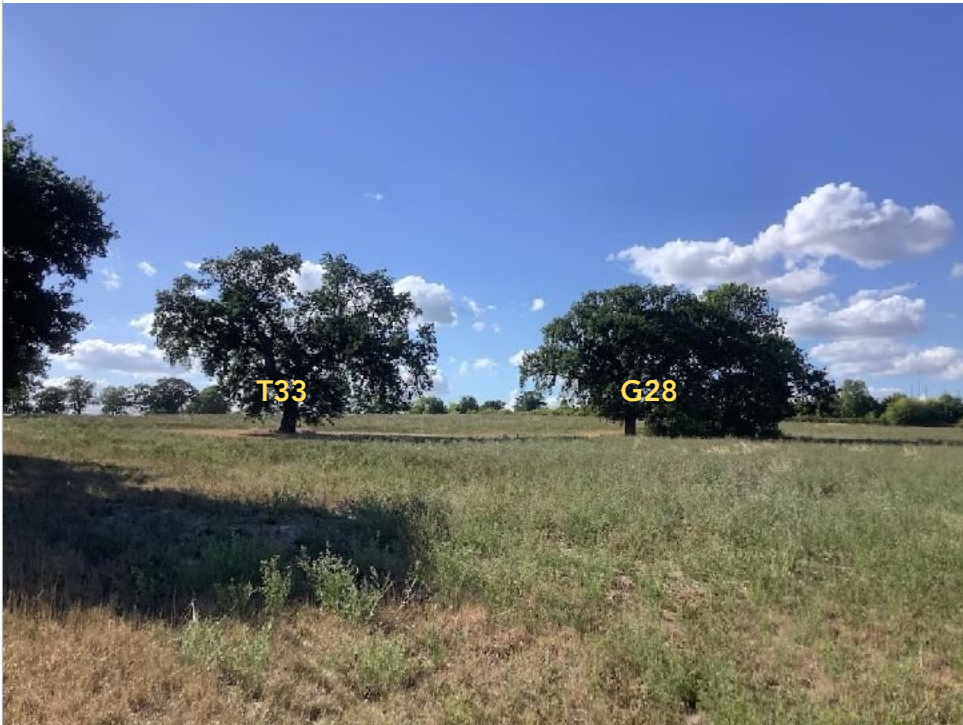
T33	Oak (English)	On	17.0	1	None	1100	9.0-10.0-11.0-9.0	0.5	1.0	N	M	None	Large included union failure to east of stem @3m causing a disjointed crown formation; moderate deadwood to east of crown @6m	Good	Fair	40+	A1	13.2	547
T34	Ash (Common)	On	10.0	8	None	1070	6.0-6.0-5.0-6.0	0.0	0.0	None	SM	None	Multi-stemmed; splits & failures to 2x significant stems with associated decay	Fair	Poor	10+	C1	12.8	518
T35	Oak (English)	On	16.0	1	None	1070	8.5-11.0-8.5-9.0	1.5	2.5	E	M	None	Historic storm damage with deadwood & occluding wounds to upper scaffold limbs; WWII pillbox to east of root-plate	Good	Fair	40+	A1	12.8	518

G28	English oak; ash; hawthorn; blackthorn	On	3 - 16	7	None	1010	8.0	1.0	M	None	3x mature oak growing around marl-pit; 2x small semi-mature ash with thorn understory; oak to north of group mildly suppressed & shows cavity to limb @4.5m in east of crown	Good	Fair	40+	A2	12.1
G29	English oak; hawthorn	Off	3 - 17	4	None	1100	8.0	1.0	M	None	4x mature oak growing offsite forming a cohesive crown; sporadic / neglected thorn hedge to boundary; southern stem showing bark loss & associated decay; 3rd stem (running north-to-south) has large hung-up limb to east of crown @6.5m	Good	Fair	40+	A2	13.2

IMAGE 1: A view looking west at T33 & G28.

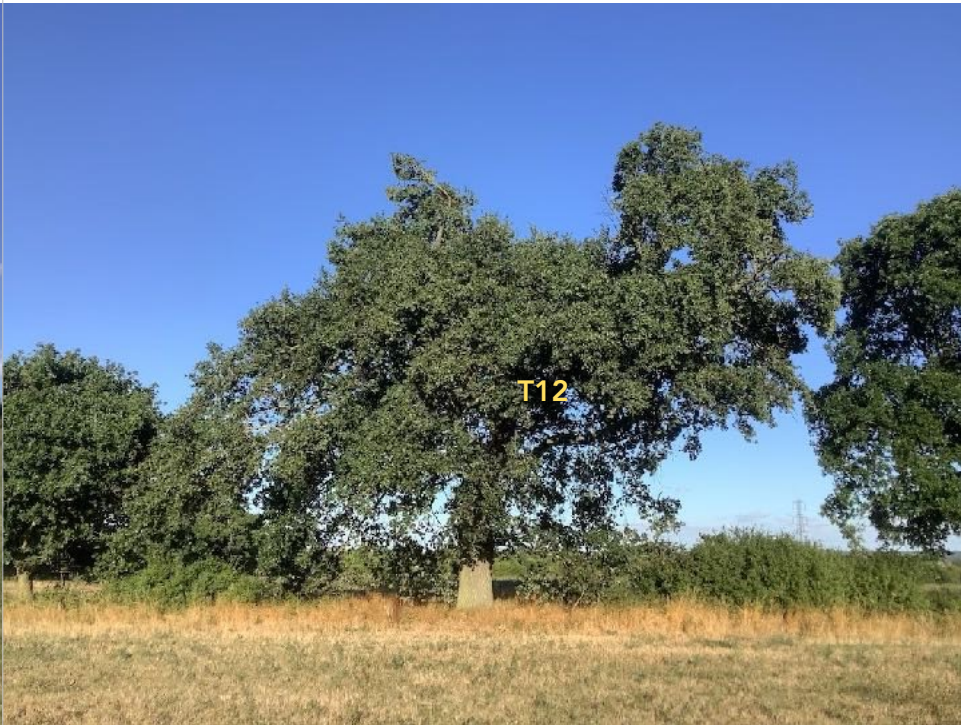
IMAGE 2: A view looking east at T12, showing the unusual crown formation.

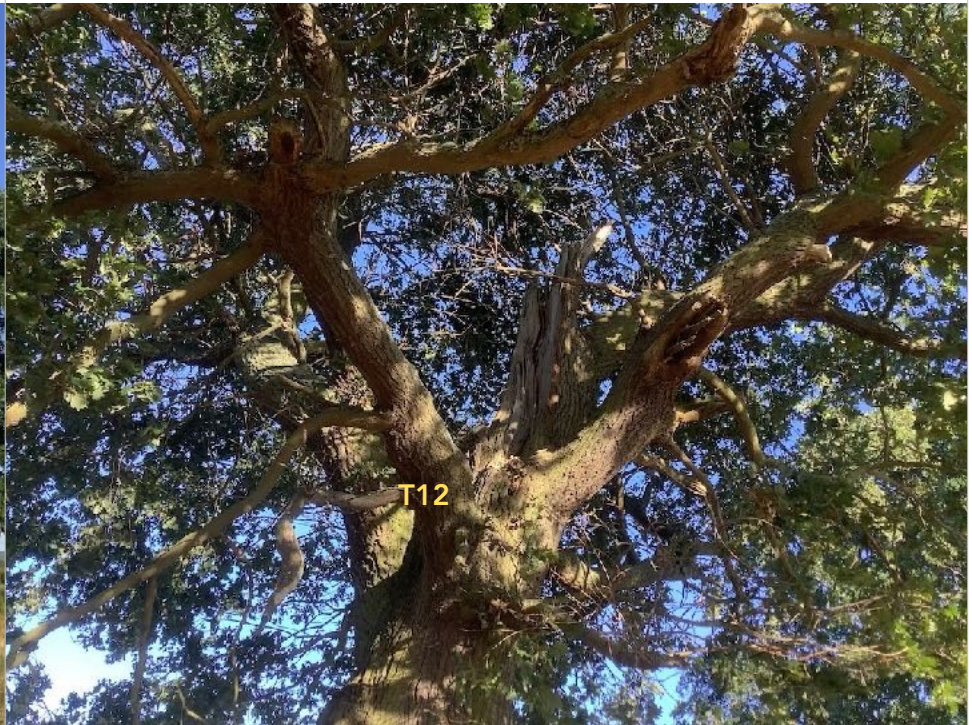
IMAGE 3: A view looking east at the damage to the central leader of T12, which has lead to the unusual crown formation.

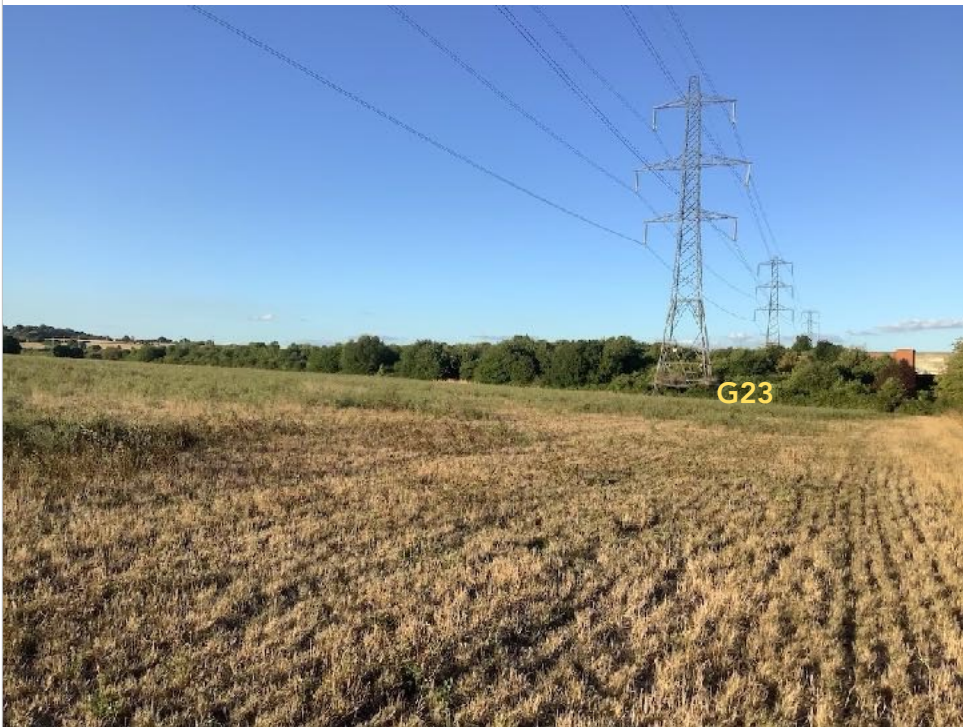
IMAGE 4: A view looking east at G23, with the abutments of Ashdale Bridge being visible to the far right of frame.

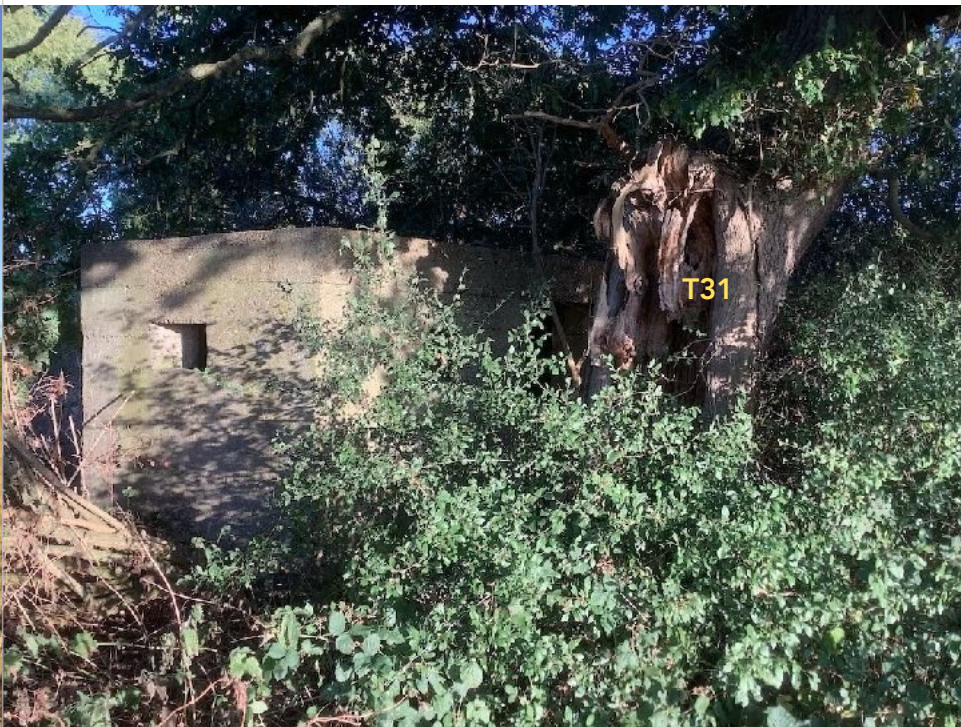
IMAGE 5: A view looking east at T31, showing the cavitation to the main stem.  
NOTE: WW II pillbox within root-plate.

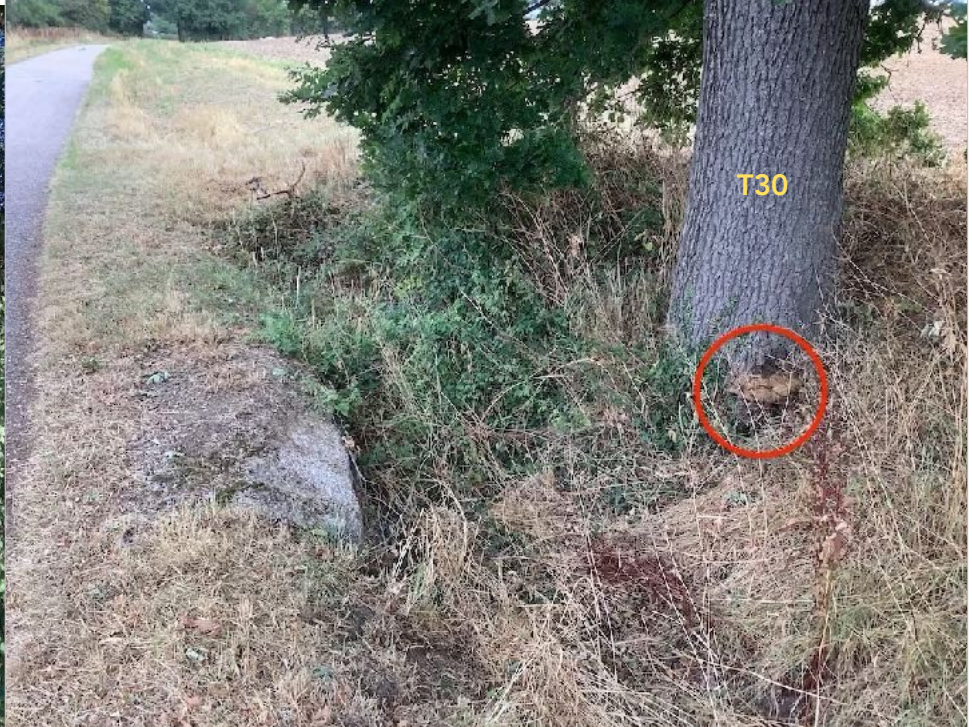
IMAGE 6: A view looking north at T30 highlighting the fungi fruiting body and showing the tree in relation to the ditch, concrete repairs / gully opening.
